Headwaters of Bridge Creek Watershed Improvement

Post-Implementation Status Report #1

215-6052-11760

Date: 5/16/2024

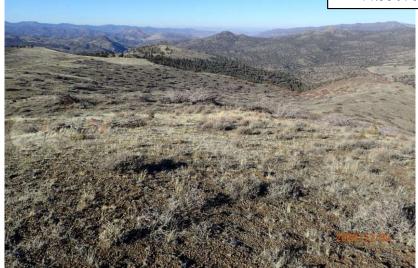
Photo Point #1 44.550767, 120.115730

Landscape view of juniper treatment. Photo from project completion report.

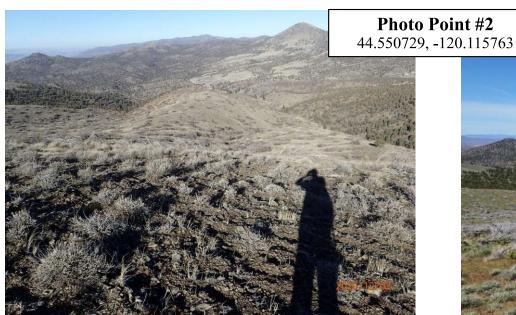
Overview of juniper removal. Photo from project completion report.

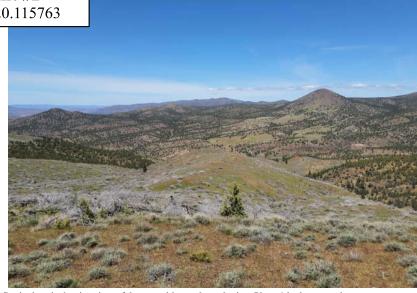
Cut juniper is showing signs of decomposition and weathering. Phase 1 juniper sparsley present.

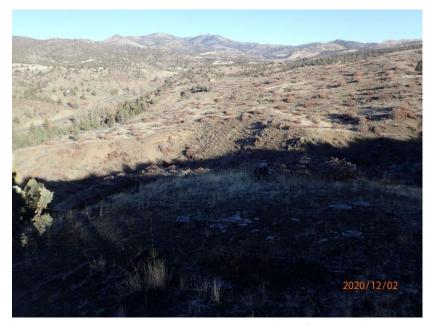
44.561194, -120.123810

Showing juniper treatment perimeter. Photo from project completion report.

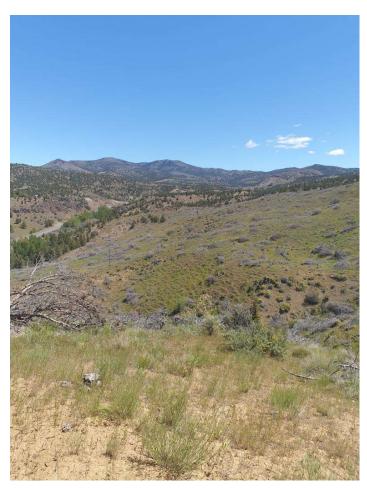
Juniper perimeter showing vegetation thriving. 05/14/2024

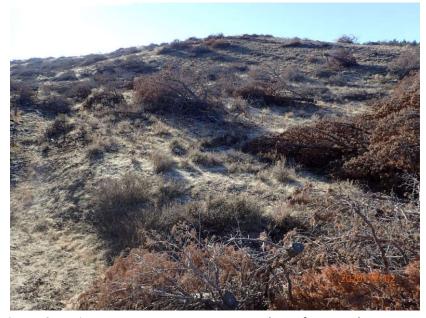
44.555813, -120.120103

View of Juniper along northern slope. Photo from project completion report.

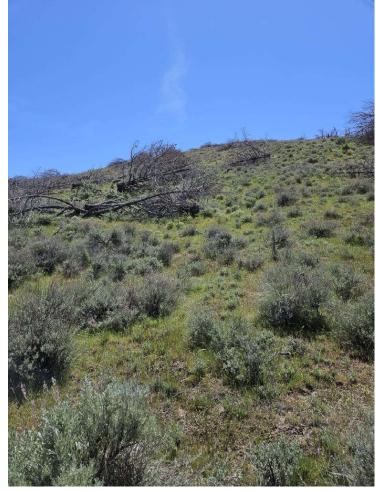
View of Juniper along northern slope with thriving herbaceous and shrub vegetation.

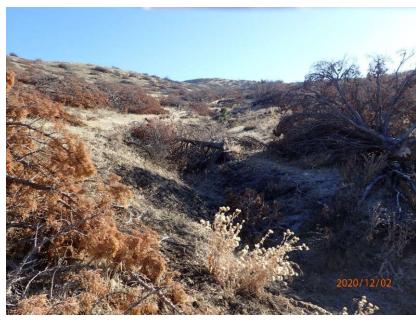
44.555863, -120.119664

Showing Juniper removal on both sides of the draw. Photo from project completion report.

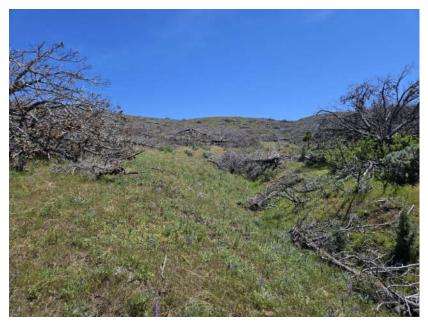
Showing Juniper removal on both sides of the draw where herbaceous vegetation is thriving and minimal bare ground visible.

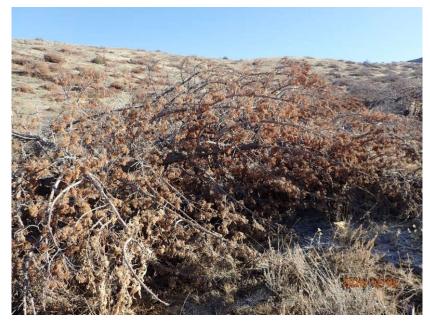
44.555727, -120.12000

Landscape view of juniper treatment along northern aspect. Photo from project completion report.

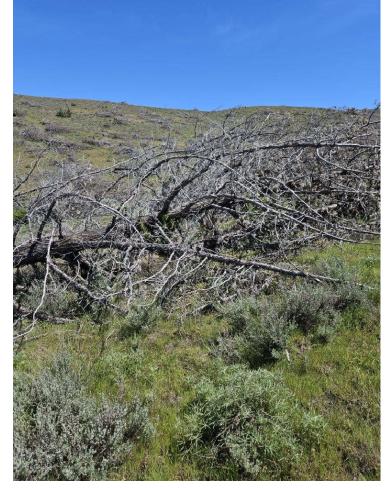
No phase 1 juniper present on northern aspect of cut. 05/14/2024

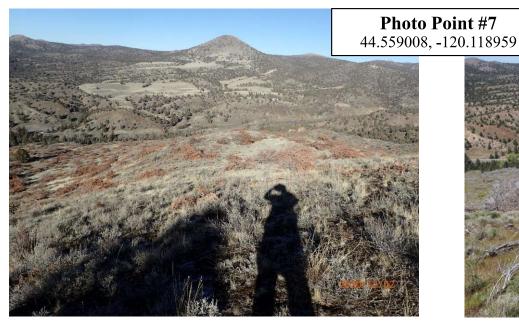
Overview of juniper removal and showing typical shrub understory. Photo from project completion report. 12/02/2020

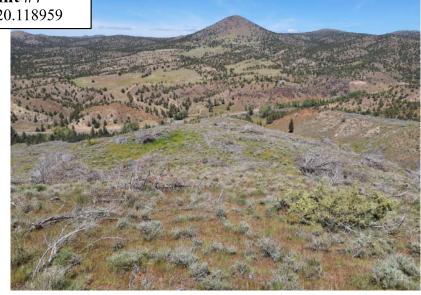
Overview of juniper removal area where no phase 1 juniper is present, and typical shrub understory is thriving. 05/14/2024

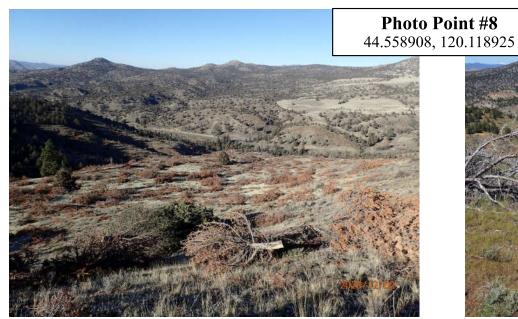
View of juniper treatment with healthy grass and shrub communities. Photo from project completion report. 12/02/2020

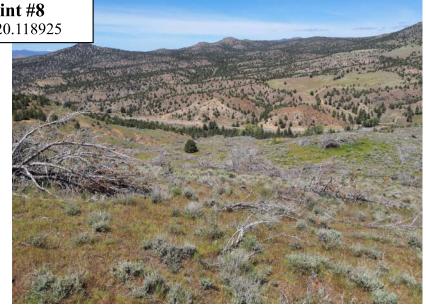
View of juniper treatment with healthy grass and shrub communities, no phase 1 juniper or bare ground visible. 05/14/2024

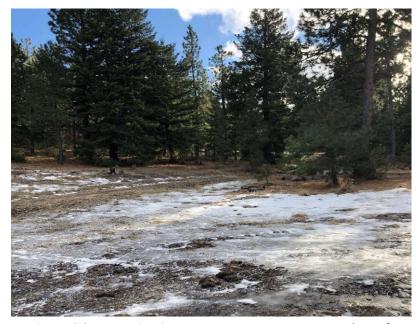
44.509863, -120.085194

Overview of forest thinning and pest management. Photo from project completion report.

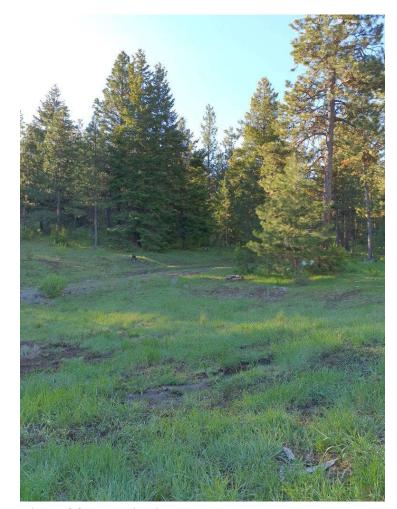
Overview of forest thinning and pest management, understory re-establishing.

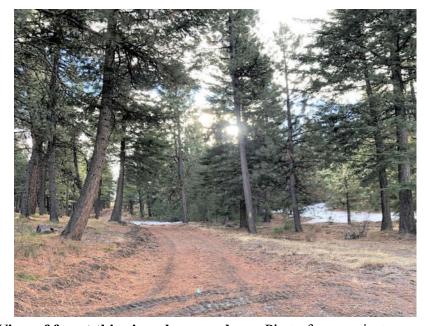
44.509228, 120.085267

View of forest thinning along roadway. Photo from project completion report.

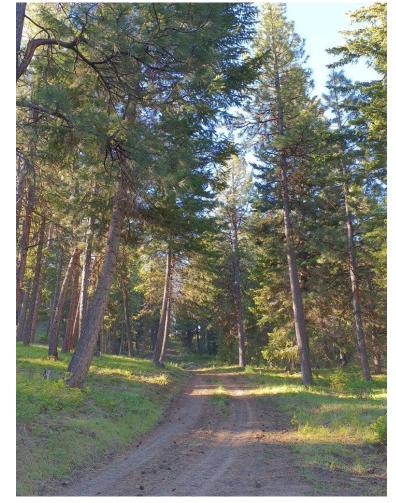
View of forest thinning along roadway, trees showing significant increase in foliage.

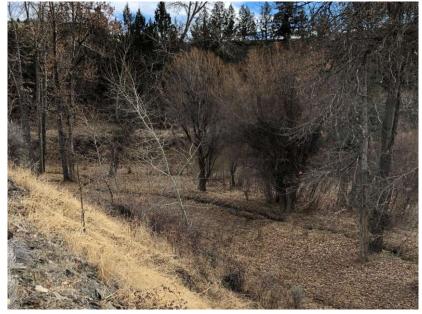
44.564825, -120.141447

Overview of riparian area along Keys Creek. Photo from

project completion report.

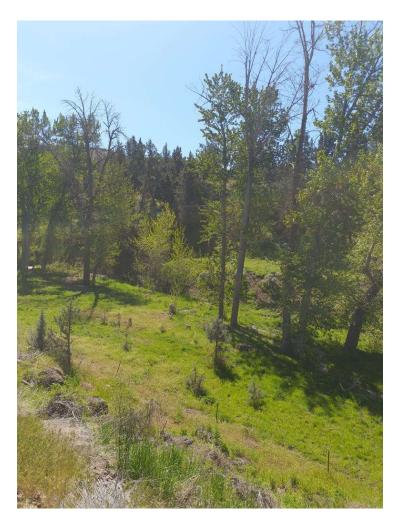
Creek full of water and trees grew tall. 05/14/2024

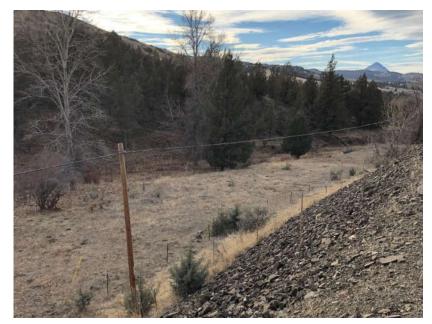
44.564836, -120.132976

Landscape view of Keys Creek. Photo from project completion report.

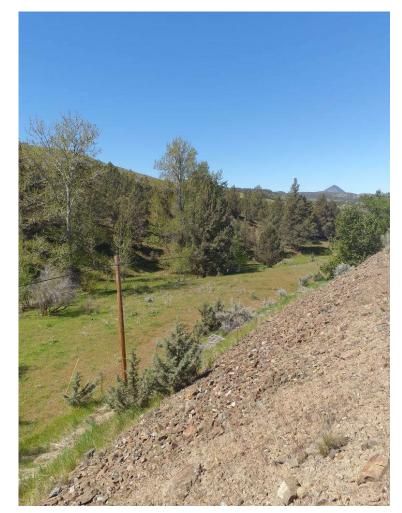
Landscape view of Keys Creek Showing vegetation increased and thriving.

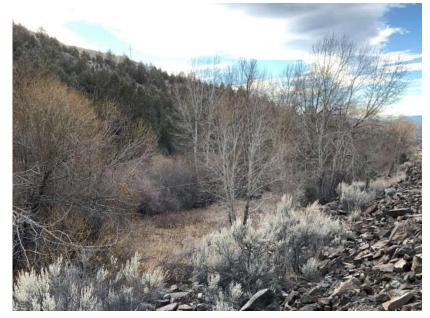
44.564548, -120.127234

View of Keys Creek and healthy woody species. Photo from project completion report.

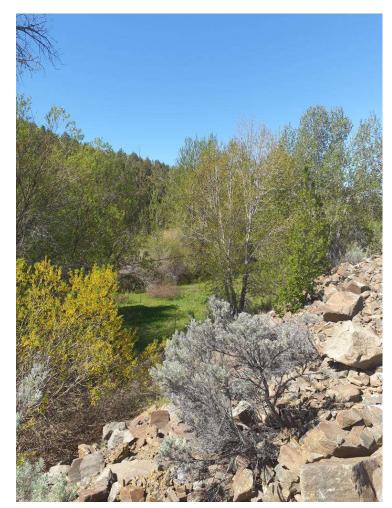
View of Keys Creek and healthy woody species that have continued to grow and fill in the understory.

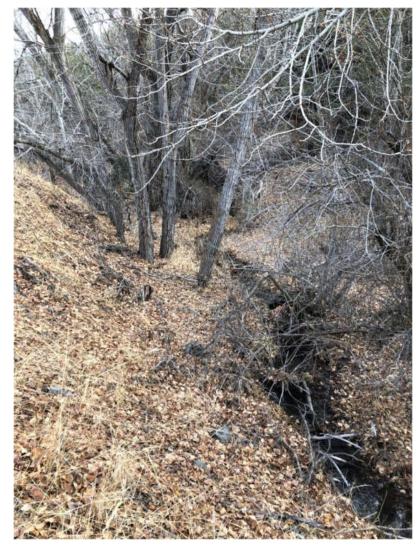
44.564881, -120.131067

Showing floodplain connectivity and woody species. Photo from project completion report.

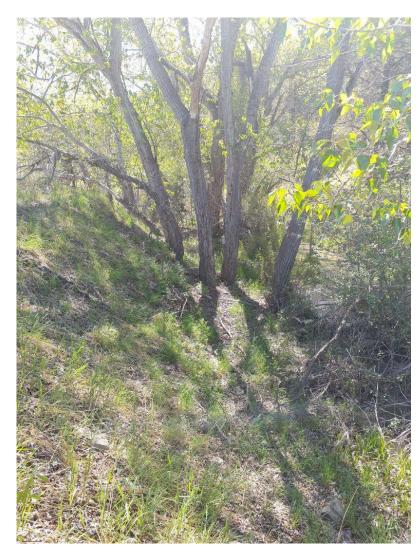
Showing floodplain connectivity and woody species thriving. Creek is full and has increased complexity.

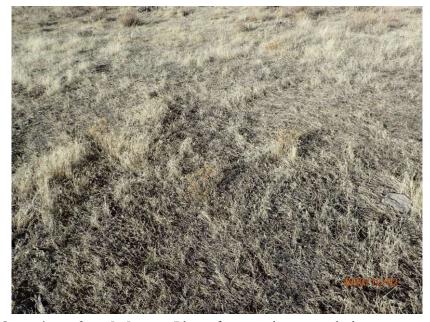
44.550181, -120.118095

Overview of seeded area. Photo from project completion report. 12/02/2020

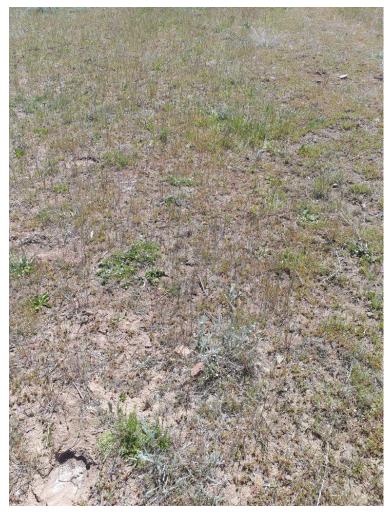
Overview of seeded area, Vegetation establishing and trees thriving, creek full of water.

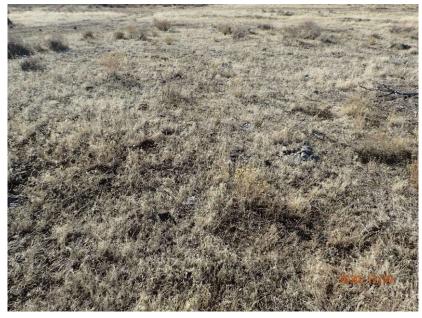
44.550154, -120.118033

View of range seeded area. Photo from project completion report.

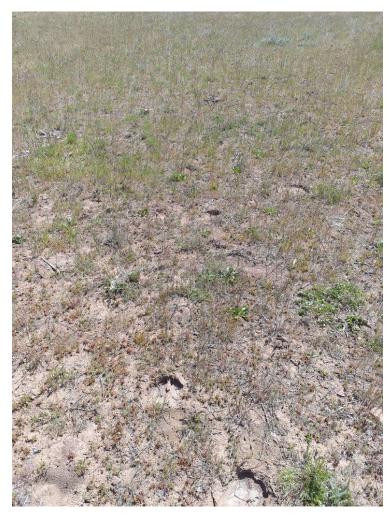
View of range seeded area, grass slowly establishing. 05/14/2024
